**FEDERAL AVIATION ADMINISTRATION  
AIRWORTHINESS DIRECTIVES  
SMALL AIRCRAFT, ROTORCRAFT, GLIDERS,  
BALLOONS, & AIRSHIPS**

**BIWEEKLY 2007-06**

**2007-04-01 Pacific Aerospace Corporation Ltd:** Amendment 39-14932; Docket No. FAA-2006-26285; Directorate Identifier 2006-CE-69-AD.

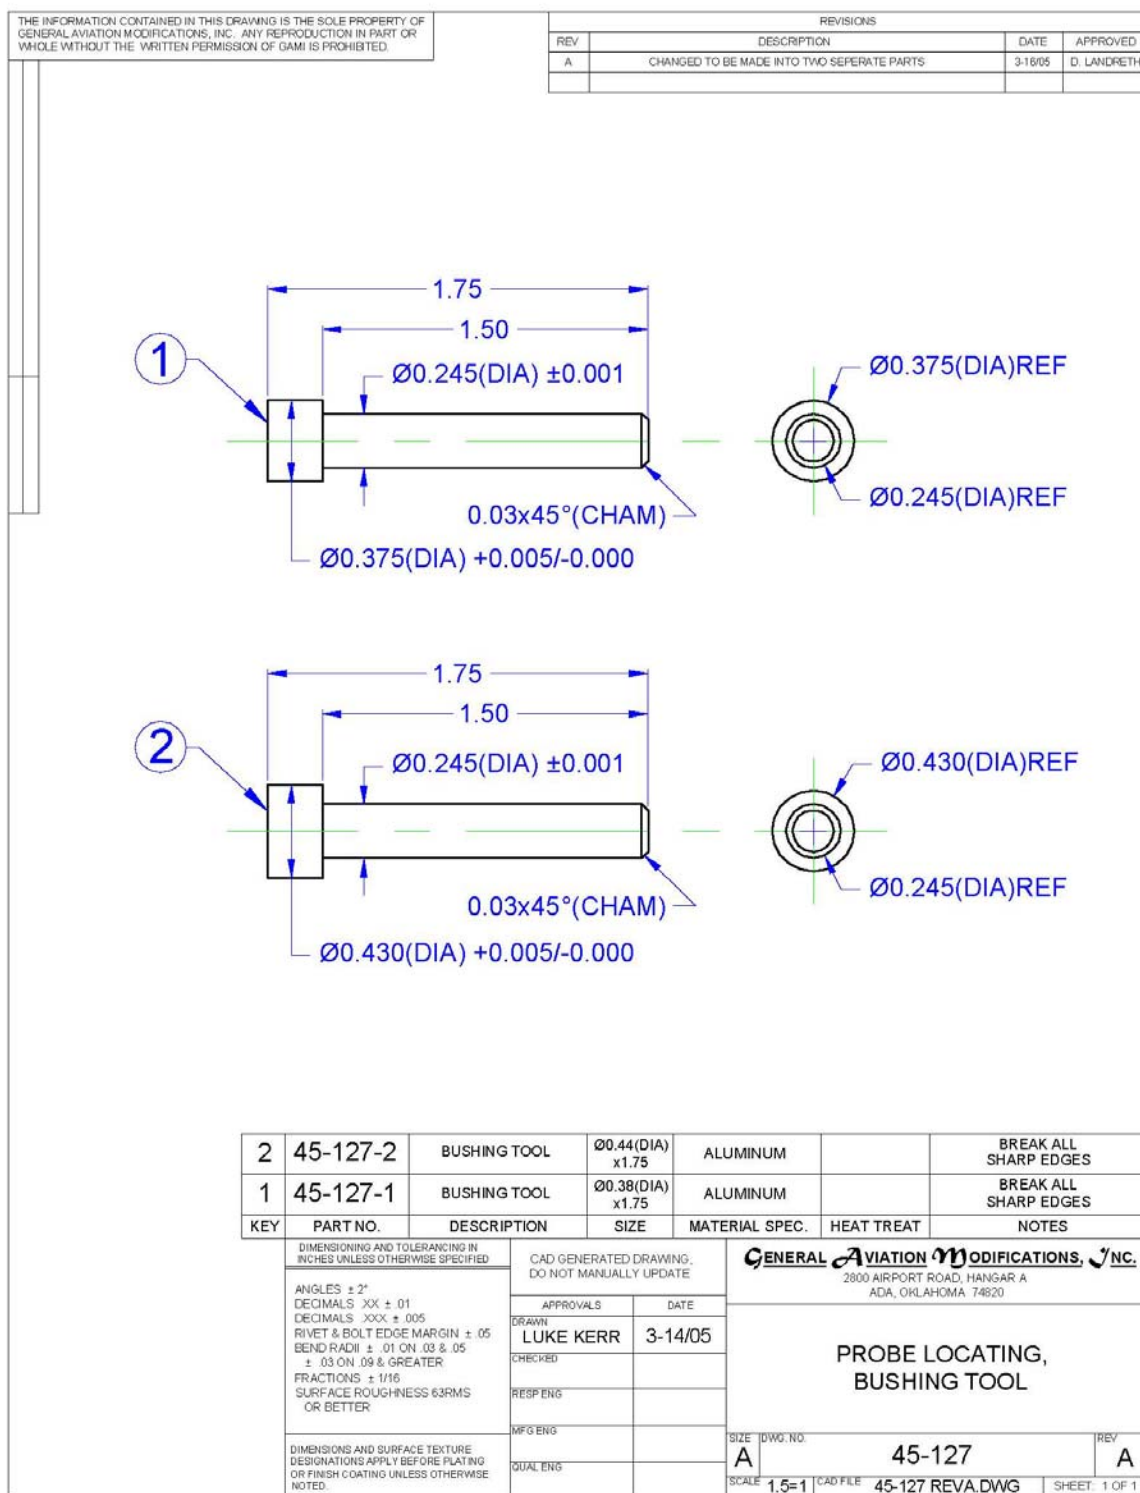
Figure 1

This procedure is to be used to detect cracks in the inner and outer spars of the front and rear spar assemblies of Raytheon Aircraft Company Beech Models 45 (YT-34), A45 (T-34A, B-45), and D45 (T-34B) airplane stabilizers outside of the steel bushings in the attach holes.

Any repeatable flaw indication is cause for rejection in accordance with the procedure. In the  
event that any crack is detected, describe the flaw in detail providing sketch as needed and  
send the information to the Wichita ACO.
